**Heavy ion Single Event Effects test of
4A Adjustable Switching regulator
MSK5042 from M. S. Kennedy**

Test Report

March 21, 2002

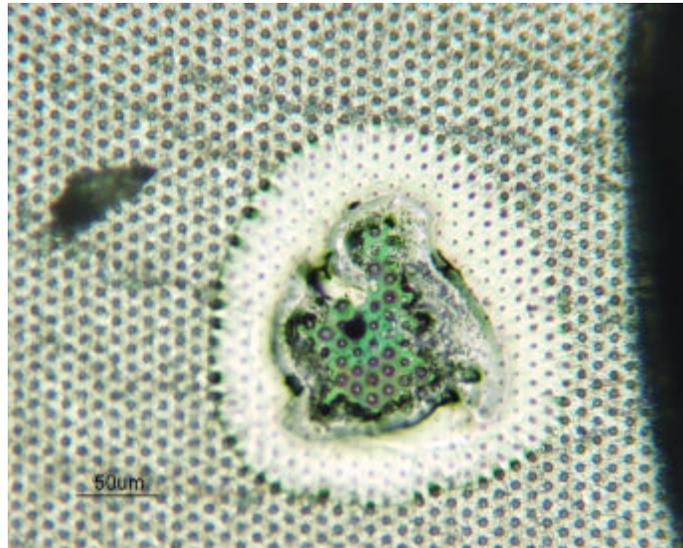
The analysis after irradiation shows that the failure occurred on the power MOSFET. A picture of the burnout of part SN1 power MOSFET is shown in Figure 2 and 3. The reason of this failure could be a heavy ion induced burnout on the IRLC034N power MOSFET, or a transient on the voltage reference or the operational amplifier that causes an overcurrent on the MOSFET.

Figure 1: burnout on Q1

The test results show that the MS5042 has a low sensitivity to transients. Two functional failures have been observed, due to burnout on the power MOSFET. These failures occurred at high LET ($>37 \text{ MeVcm}^2/\text{mg}$), but the sensitivity could be significantly higher for high load conditions. The most probable cause is the heavy ion induced burnout on power MOSFET. The use of higher voltage MOSFET (ie. 100V devices) will give a lower sensitivity. A design analysis is also recommended to study the impact of transients on the voltage reference and the operational amplifier.

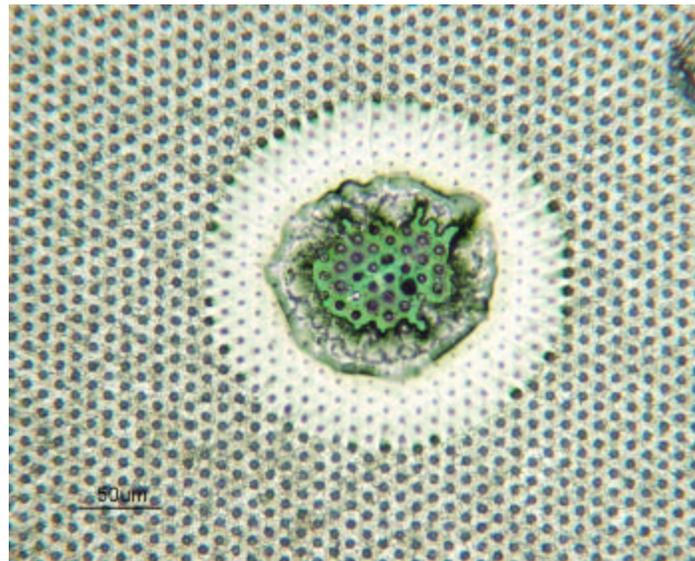
Figure 2: burnout on Q2
